Collision Involving Three BNSF Railway Freight Trains
near Amarillo, Texas
September 25, 2013

NTSB/RAR-15/02
PB2015-105169

NTSB/RAR-15/02
PB2015-105169
Notation 8618
Adopted June 25, 2015

Railroad Accident Report

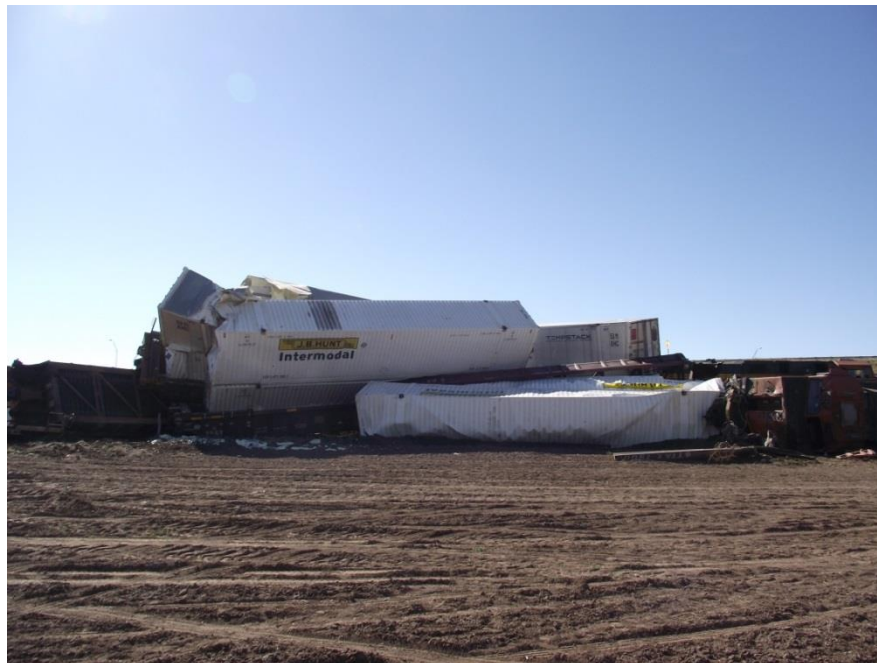
On September 25, 2013, at 4:17 a.m. central daylight time, BNSF Railway (BNSF) eastbound train BLACWSP223A (7891 East) struck the rear end of BNSF train SLHTLPC223A (6746 East) on main track no. 2 near Amarillo, Texas.¹ Several cars from 7891 East derailed and fell across the adjacent track, main track no. 1. Approaching BNSF westbound train ZWSPSBD724L (6943 West) struck the derailed cars. (See figure 1.)

Figure 1. Derailed cars from trains 7891 East and 6943 West.

After the train struck the rear of 6746 East, several cars behind 7891 East derailed and fell across the adjacent track. Once the train stopped, the conductor used the radio to call train 6943 West, which was approaching on track no. 1, to tell the crew to stop their train.

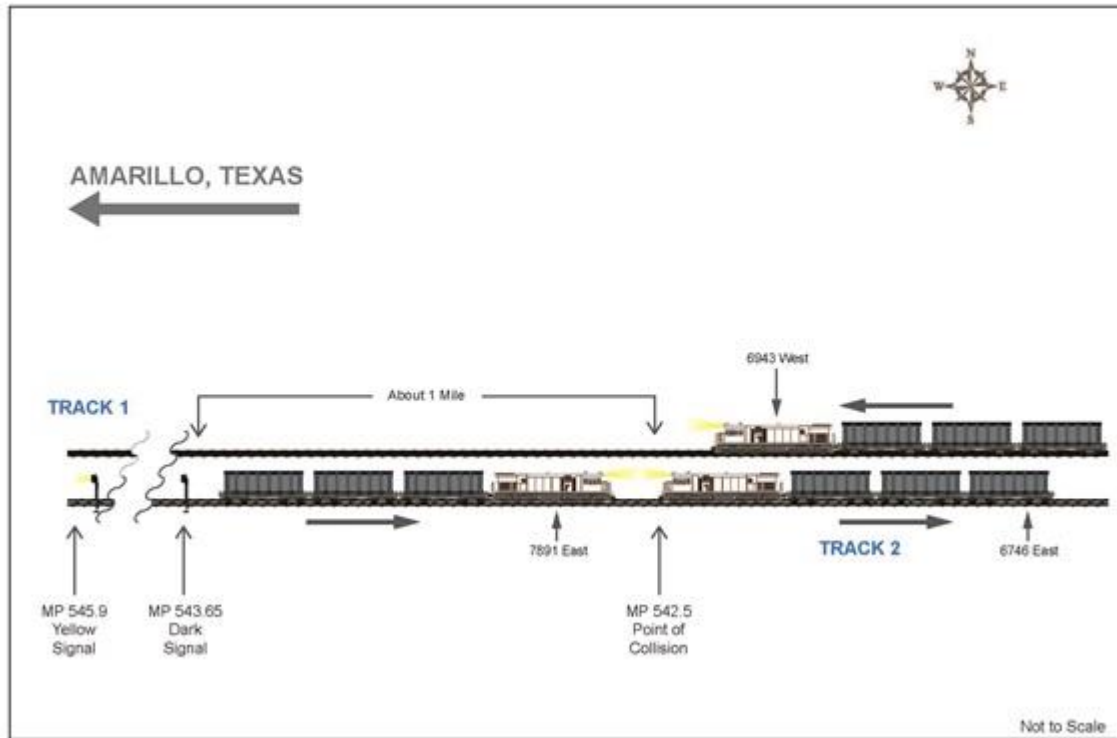
the signal at MP 543.65 was dark, the crew should have expected a signal to be displayed at that location.

Figure 2. Diagram of the tracks and signals at the accident scene.

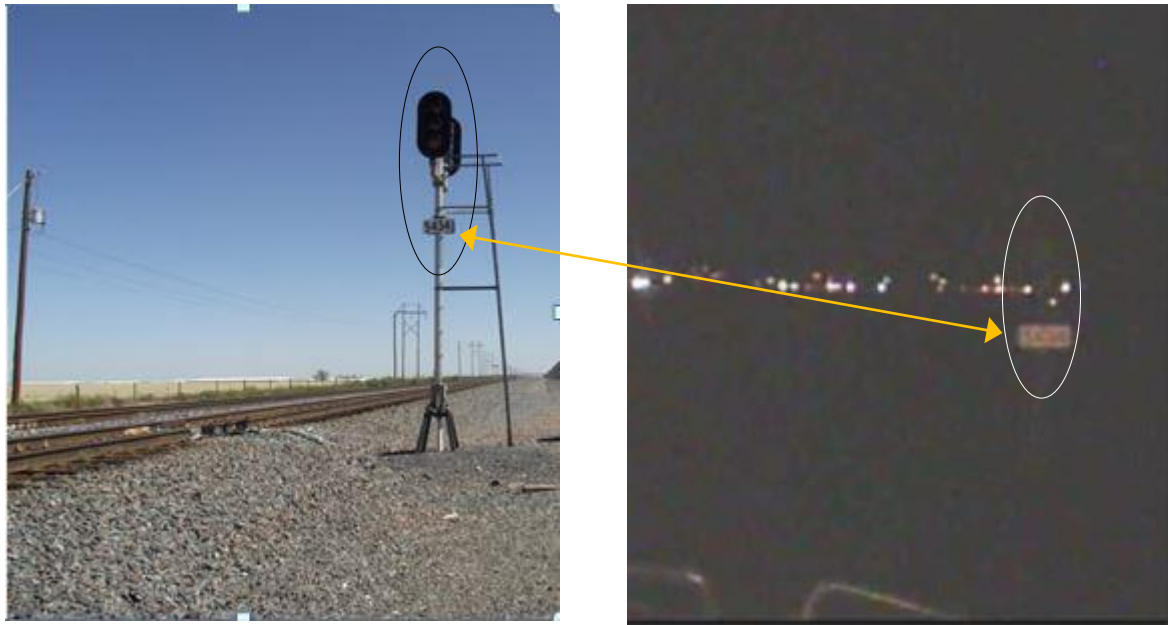
³ NTSB investigators confirmed that the signal at MP 545.9 displayed a yellow aspect and the signal at MP 543.65 was dark. Testing confirmed that only the signal lamp used to display a red aspect was burned out; The *General Code of Operating Rules*, Sixth Edition, Effective April 7, 2010, Rule 9.4, “Improperly Displayed Signals or Absent Lights,” requires that a dark signal be regarded as displaying the most restrictive indication.

Investigators reviewed forward-facing video of the dark signal from the lead locomotive and determined that it was visible for about 2 seconds on approach. (See figure 3.)

Figure 3. Day and night photos of signal at MP 543.65. Photo on right is from the forward-facing camera of train 7891 East.

⁵ The signal had three aspects—green, yellow, and red—illuminated by separate lamps. The only lamp that was burned out was the red aspect. If the previous train had either a yellow, flashing yellow, or green signal aspect, the crew would not have encountered the dark signal.

According to the interviews, the two crewmembers had been calling the signals to each other; however, they did not observe the dark signal at MP 543.65. The dark signal at MP 543.65 required the train to stop and then proceed in the signal block beyond the signal at restricted speed. At restricted speed, the crewmembers in the operating cab would have been required to maintain a speed that would have allowed stopping the train in half the range of vision short of a stopped train, not exceeding 20 mph. The crew of 7891 East stated that they did not see the dark signal. The NTSB concludes that the crew of train 7891 East failed to observe the

wayside signal at MP 543.65 that was dark (improperly displayed) with a burned-out light for the red aspect.

The current design of PTC includes automatic block signal locations. Although the lamp was burned out in this particular signal, the signal circuitry would have identified this as a stop location. A PTC system would have warned the engineer in the locomotive cab of the upcoming restrictive signal. If the engineer had not responded, the PTC system would have automatically applied the brakes and stopped the train before the train passed the signal at MP 543.65. Therefore, the NTSB concludes that had the territory been equipped with PTC, the train would have been stopped at the signal at MP 543.65, regardless of the light's being burned out.

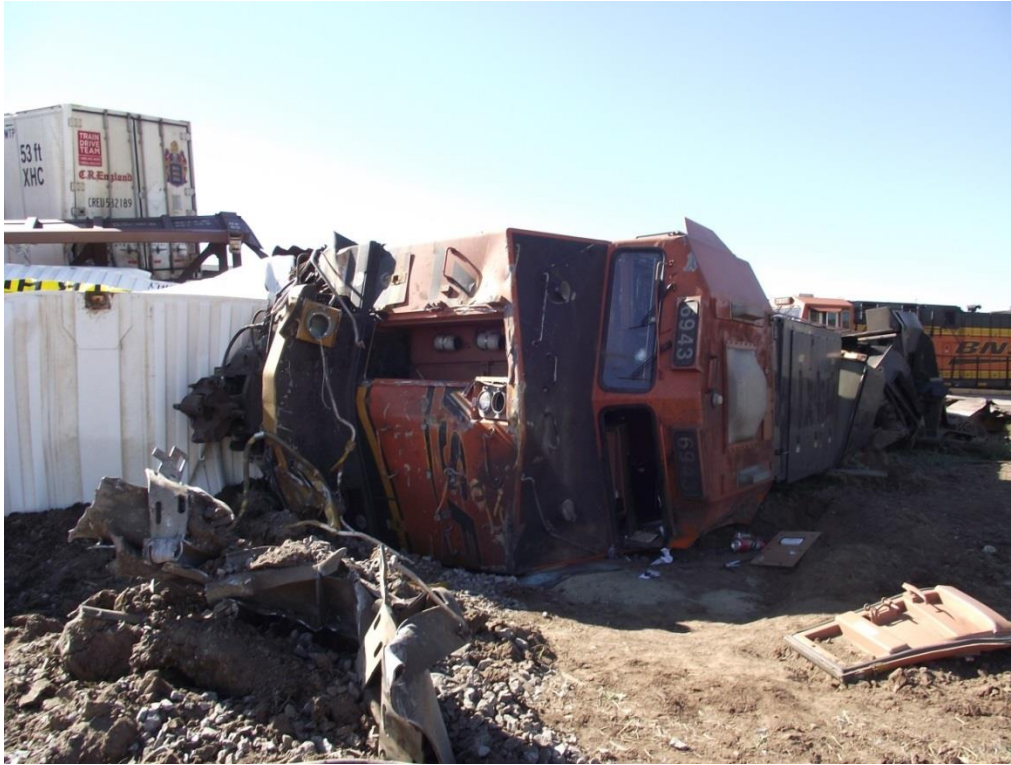
Train 6943 West departed Wellington, Kansas, at 12:09 a.m. The engineer and the conductor had gone on duty September 24, 2013, at 10:00 p.m. The engineer told NTSB investigators that, while operating on main track no. 1 and passing an eastbound train on main track no. 2 near MP 542.0, he heard the conductor from 7891 East announce on the radio “emergency, emergency, emergency.” He also heard the conductor on 7891 East advise him to stop the train. Just seconds later, he observed a railroad car lying crossways on main track no. 1. He applied the emergency brakes, and both crewmembers braced for impact. (See figure 4.)

Figure 3. Lead locomotive of 6943 West.
